# Manhole Inspection Summary

Manhole # S27K\_\_003MH

Insp Date: **6/3/08 9:47 AM**

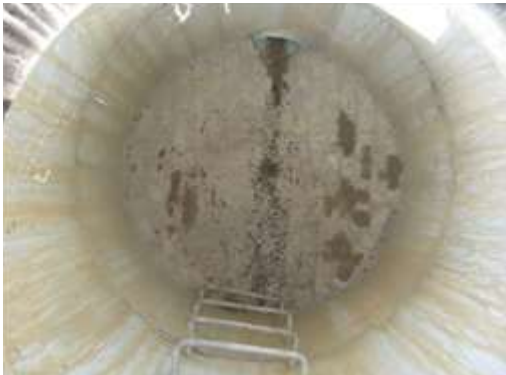
Top View

Comments **bench is brick with concrete covering.**

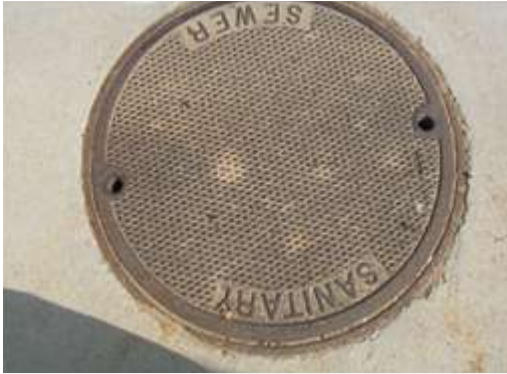
Cover View

Type: **Sanitary** Condition: **Sound** Cover Material: **Cast Iron**

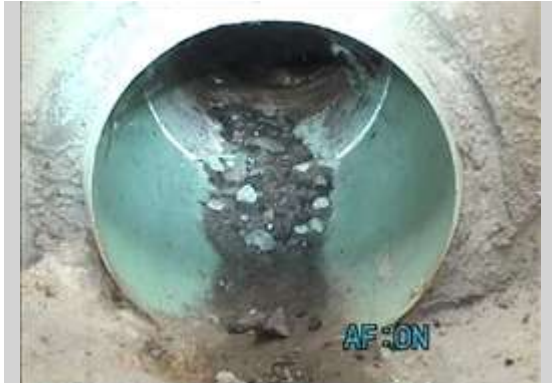
12 O'Clock Outflow

8 in. Circular Gravity Sewer  
Pipe Out @ 12 O'Clock

Deposits: ☐ None ☐ Mud ☐ Sludge ☒ **Debris** ☐ Grease

Silt Depth: **0.5** (in.) Deposits Extent: **Light**
